Structural Assessment

THE STRUCTURE

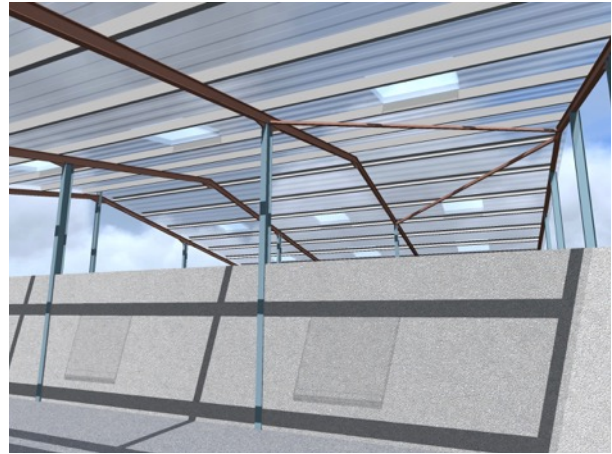
The model shows the horizontal wind bracing (roof) and the vertical wind bracing (concrete block walls)
